# Wittler Project

# Overview

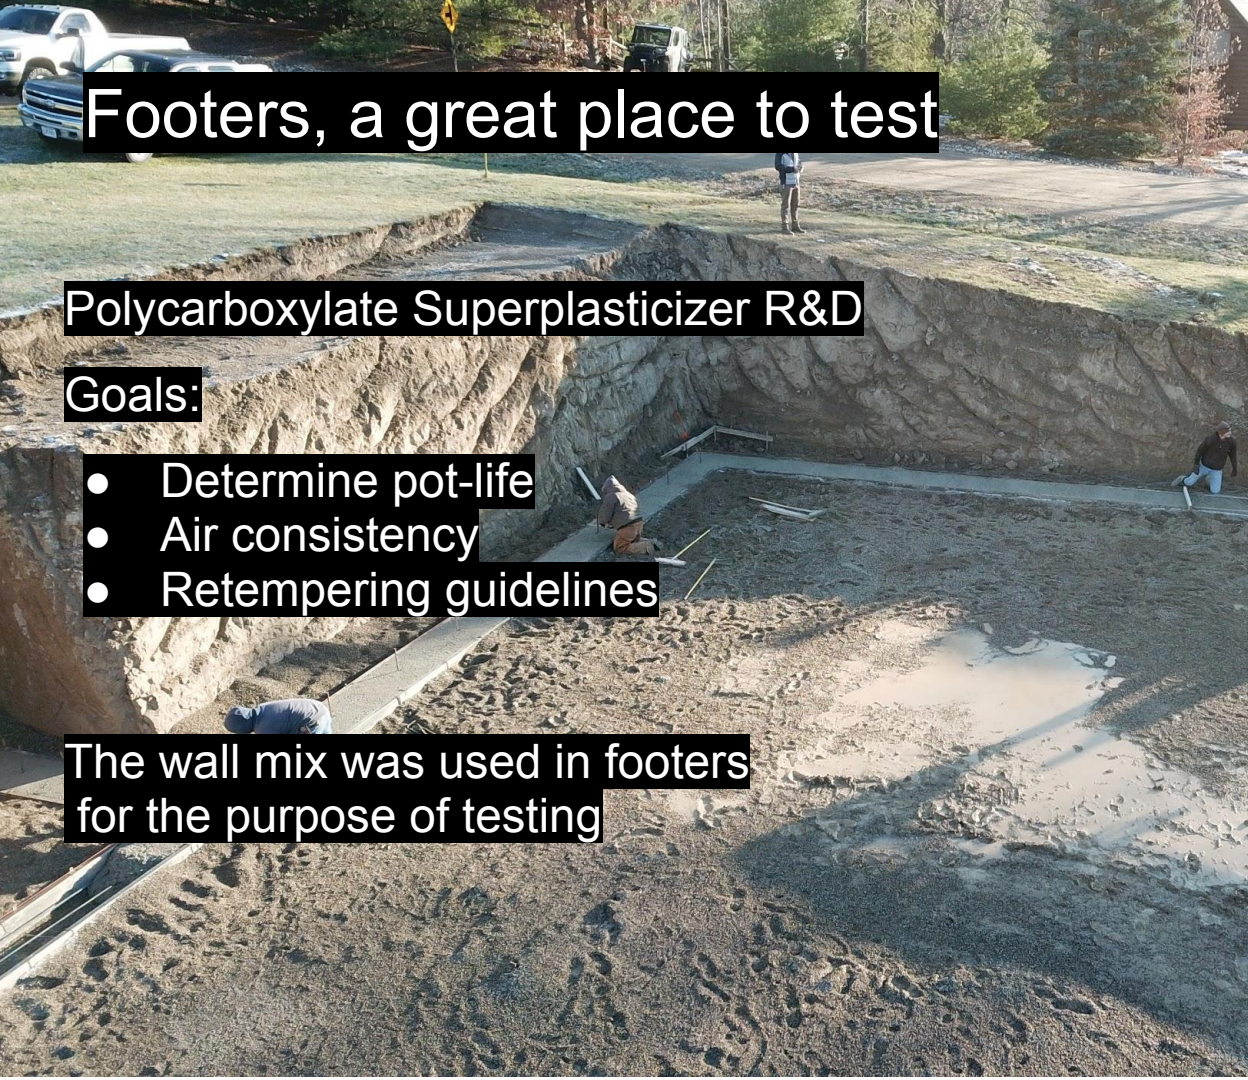
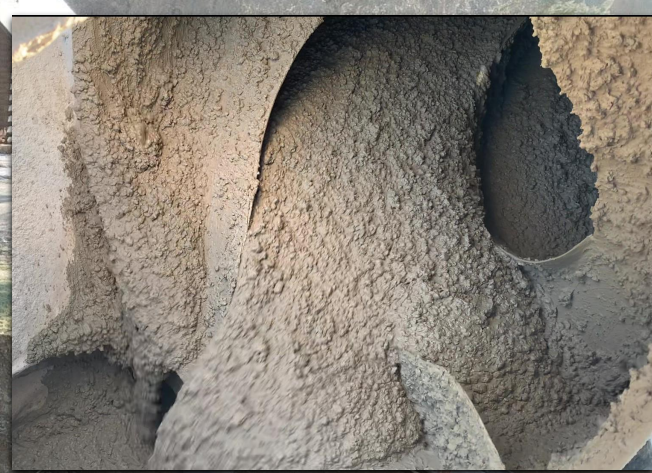
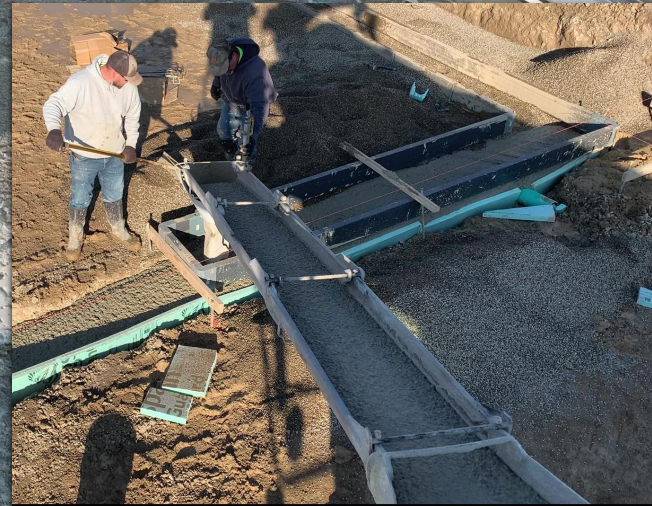
# Footers, a great place to test

## Polycarboxylate Superplasticizer R&D

### Goals:

- Determine pot-life
- Air consistency
- Retempering guidelines

The wall mix was used in footers for the purpose of testing

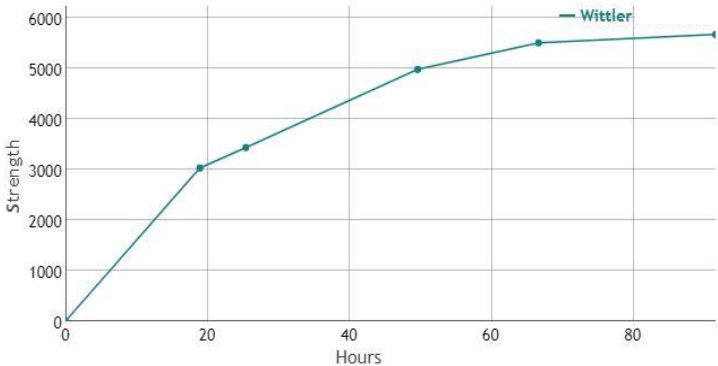
## Edit Maturity Curve Data

Hours	Strength
0	0
20	3000
25	3400
50	5000
65	5500
90	5800

Break Date	Age (Hours)	TTF	Brk 1	Brk 2	Brk 3	Avg
2020-11-30 01:00 PM	DATE CAST					
2020-12-01 08:00 AM	18.96	0.0	3040	3020	0	3030
2020-12-01 02:25 PM	25.44	0.0	3350	3520	0	3435
2020-12-02 02:35 PM	49.68	0.0	4960	5000	0	4980

## Creating maturity curve benchmark

### Maturity Considerations:

Be conservative

Highest allowable air

Highest allowable w/c

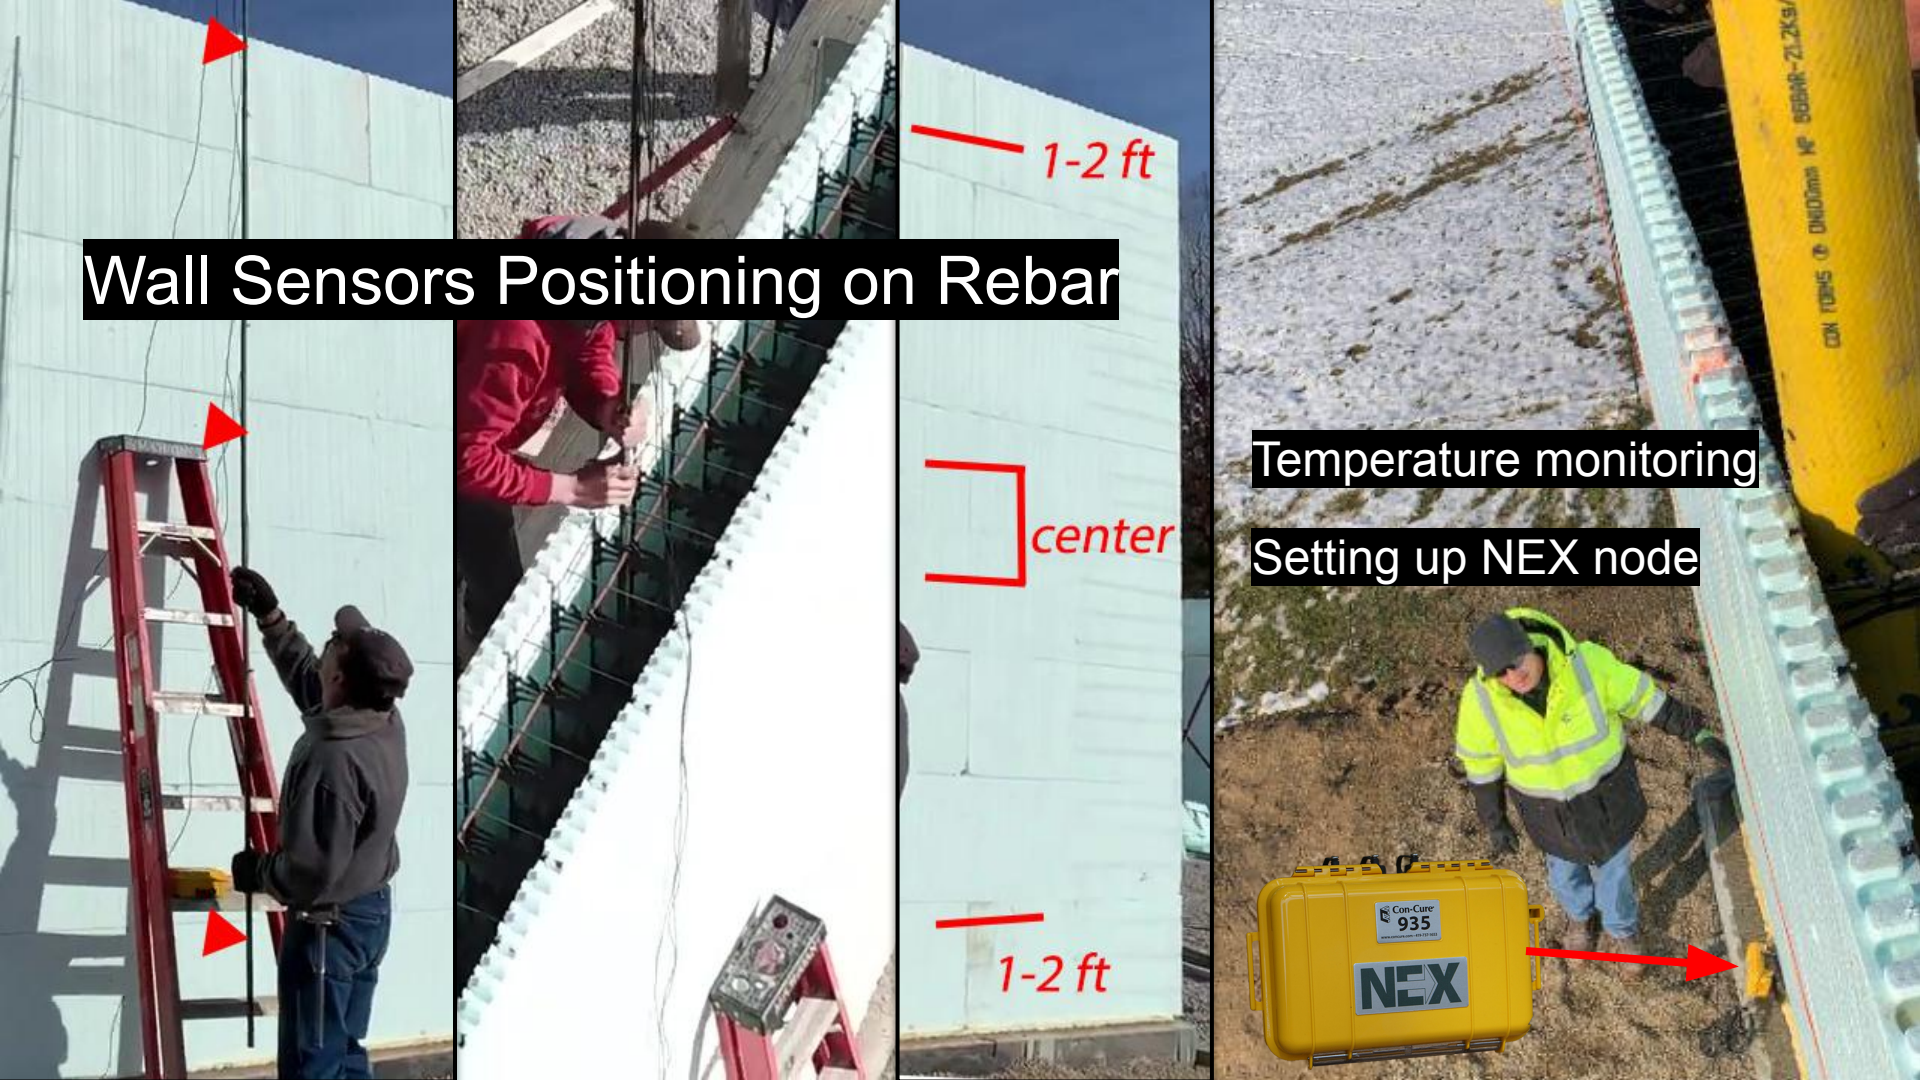
# Wall Sensors Positioning on Rebar

Temperature monitoring

Setting up NEX node

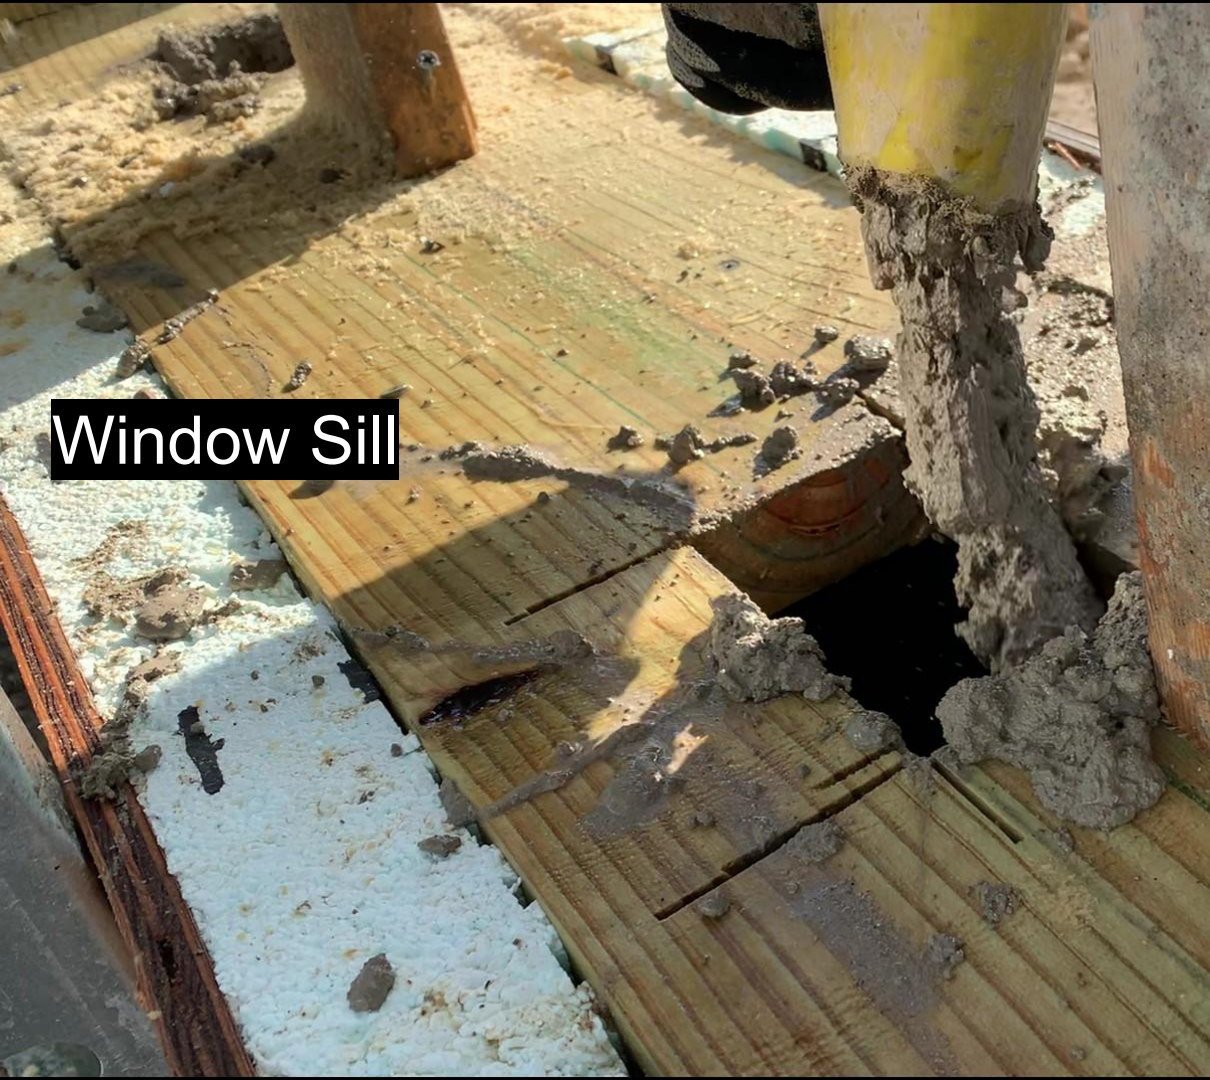
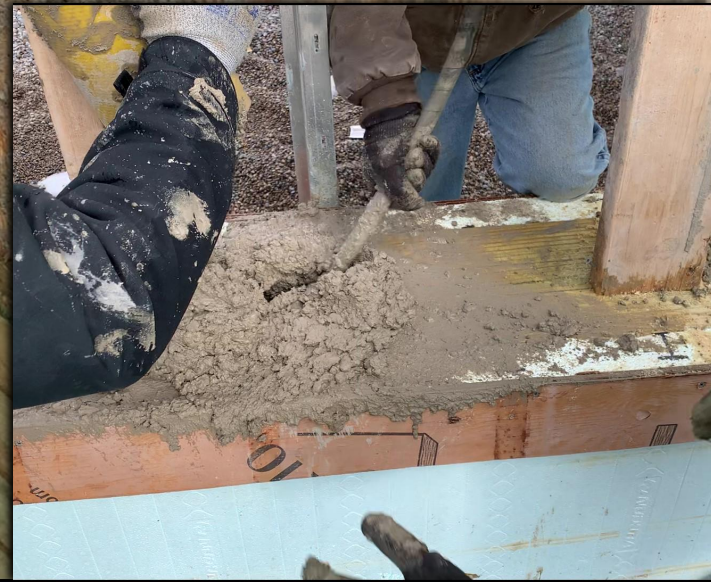
Placed with 4' lifts

80 yards to pump

ICF and blowout concern

Mix details

564 lbs cement

.50 w/c ratio

5-6% air

7-7.5" slump

Truck	Slump	Air	Temp
3	7.00	5.4%	55.0F
4	8.00	5.4%	56.0F
5	7.50	5.4%	56.0F
6	7.00	5.3%	56.0F

Time from batch to placement  
approximately 45 minutes.  
No retempering on footers.  
Moderate retempering on walls.

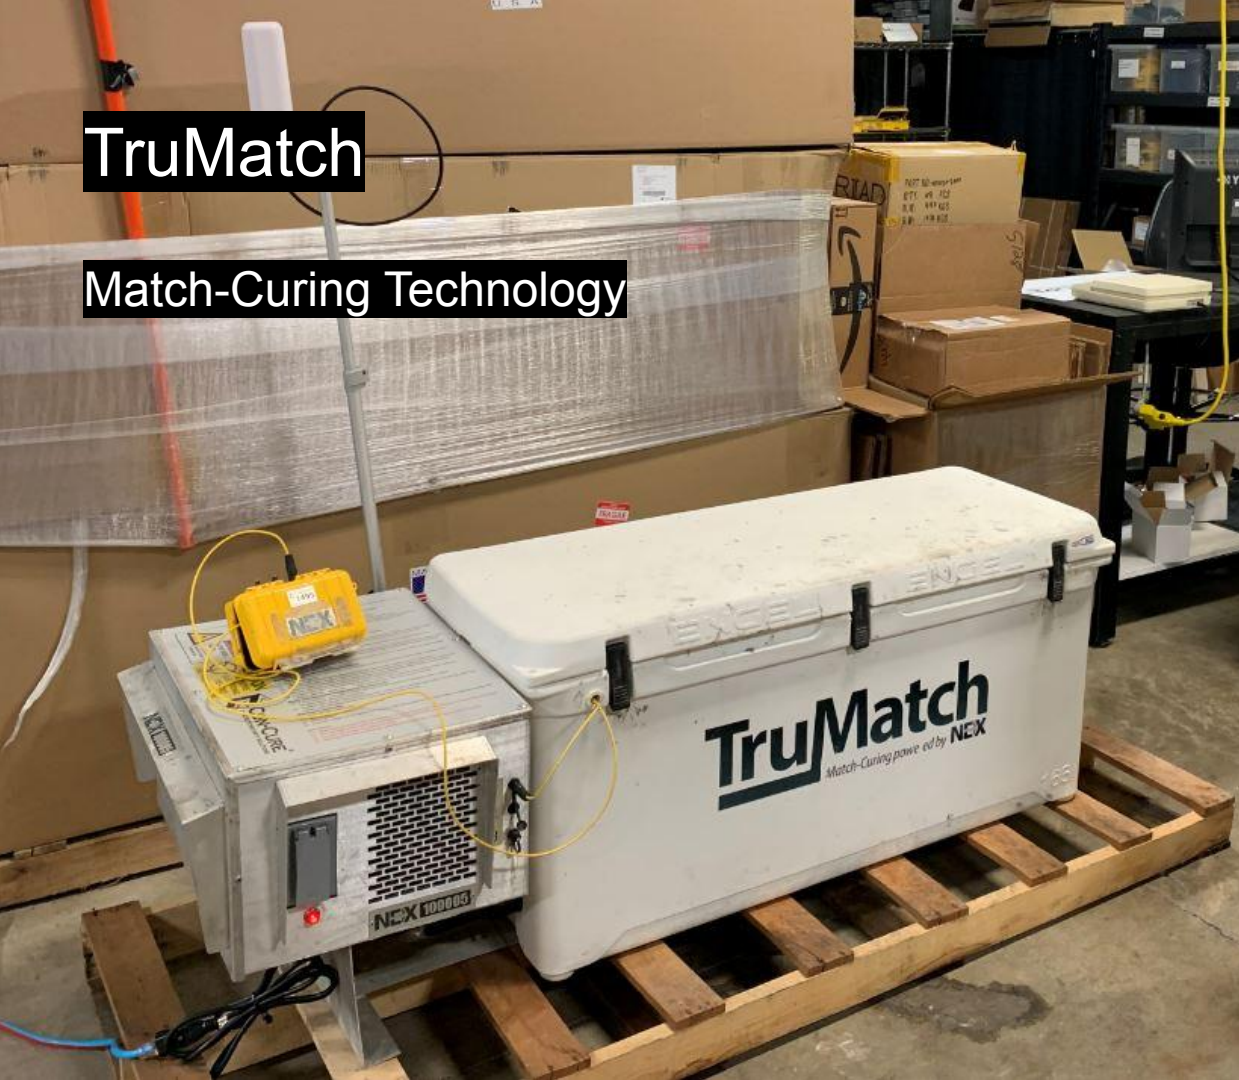
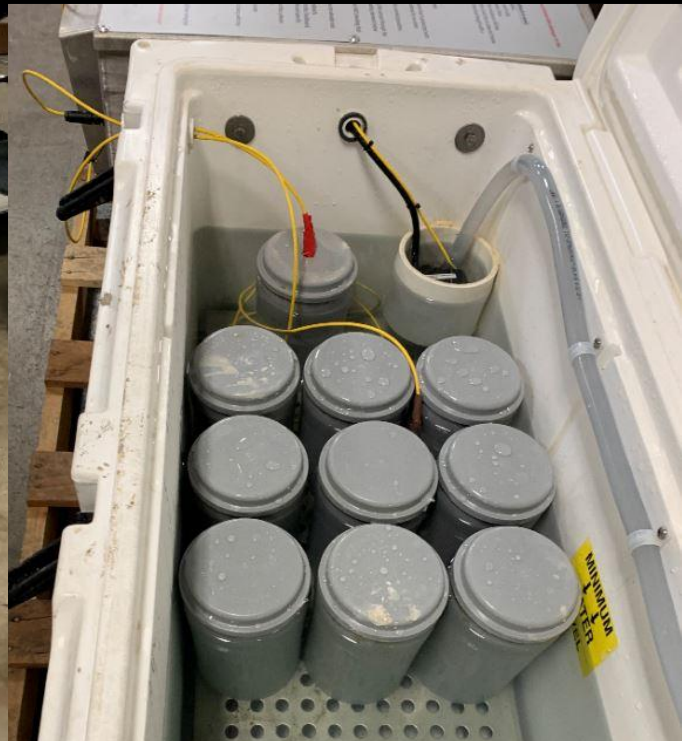
# TruMatch

## Match-Curing Technology

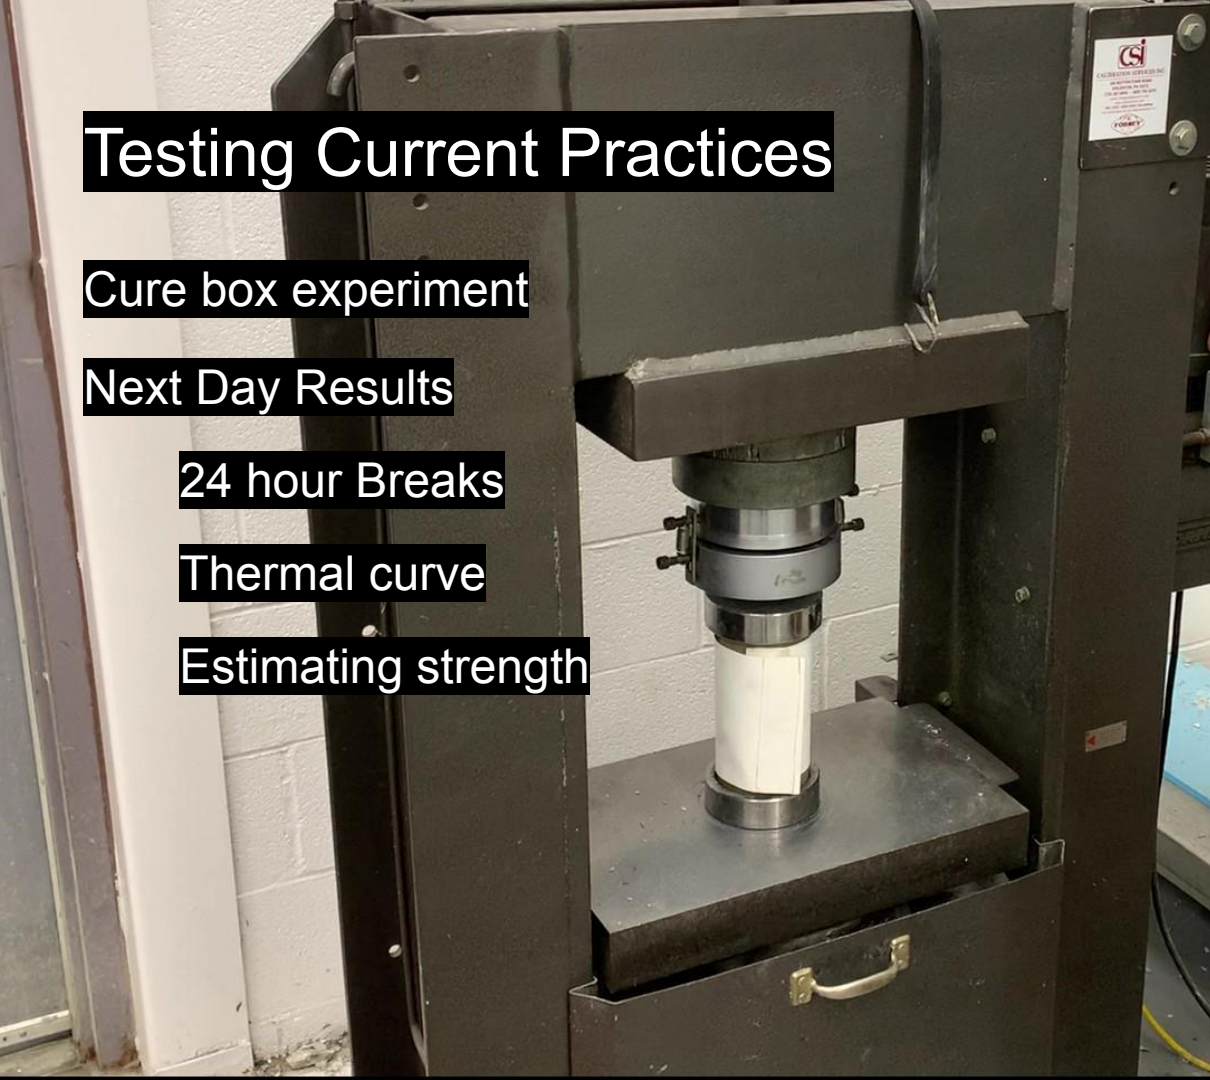
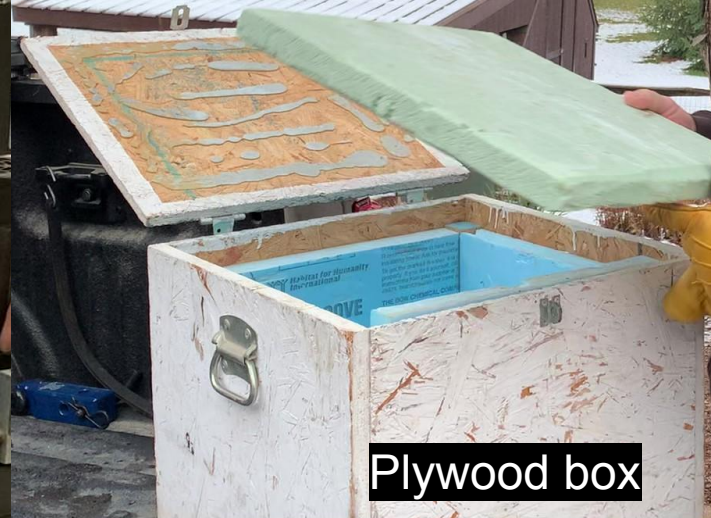
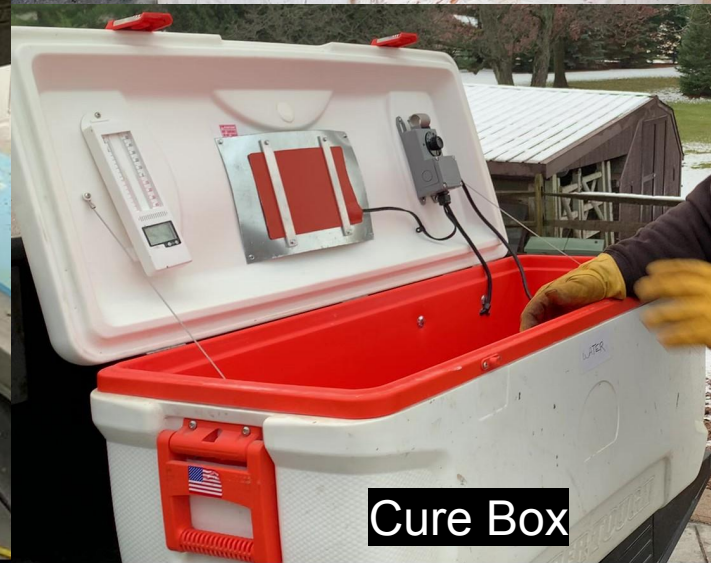
# Testing Current Practices

Cure box experiment

Next Day Results

24 hour Breaks

Thermal curve

Estimating strength

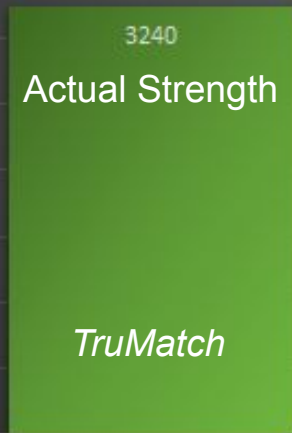
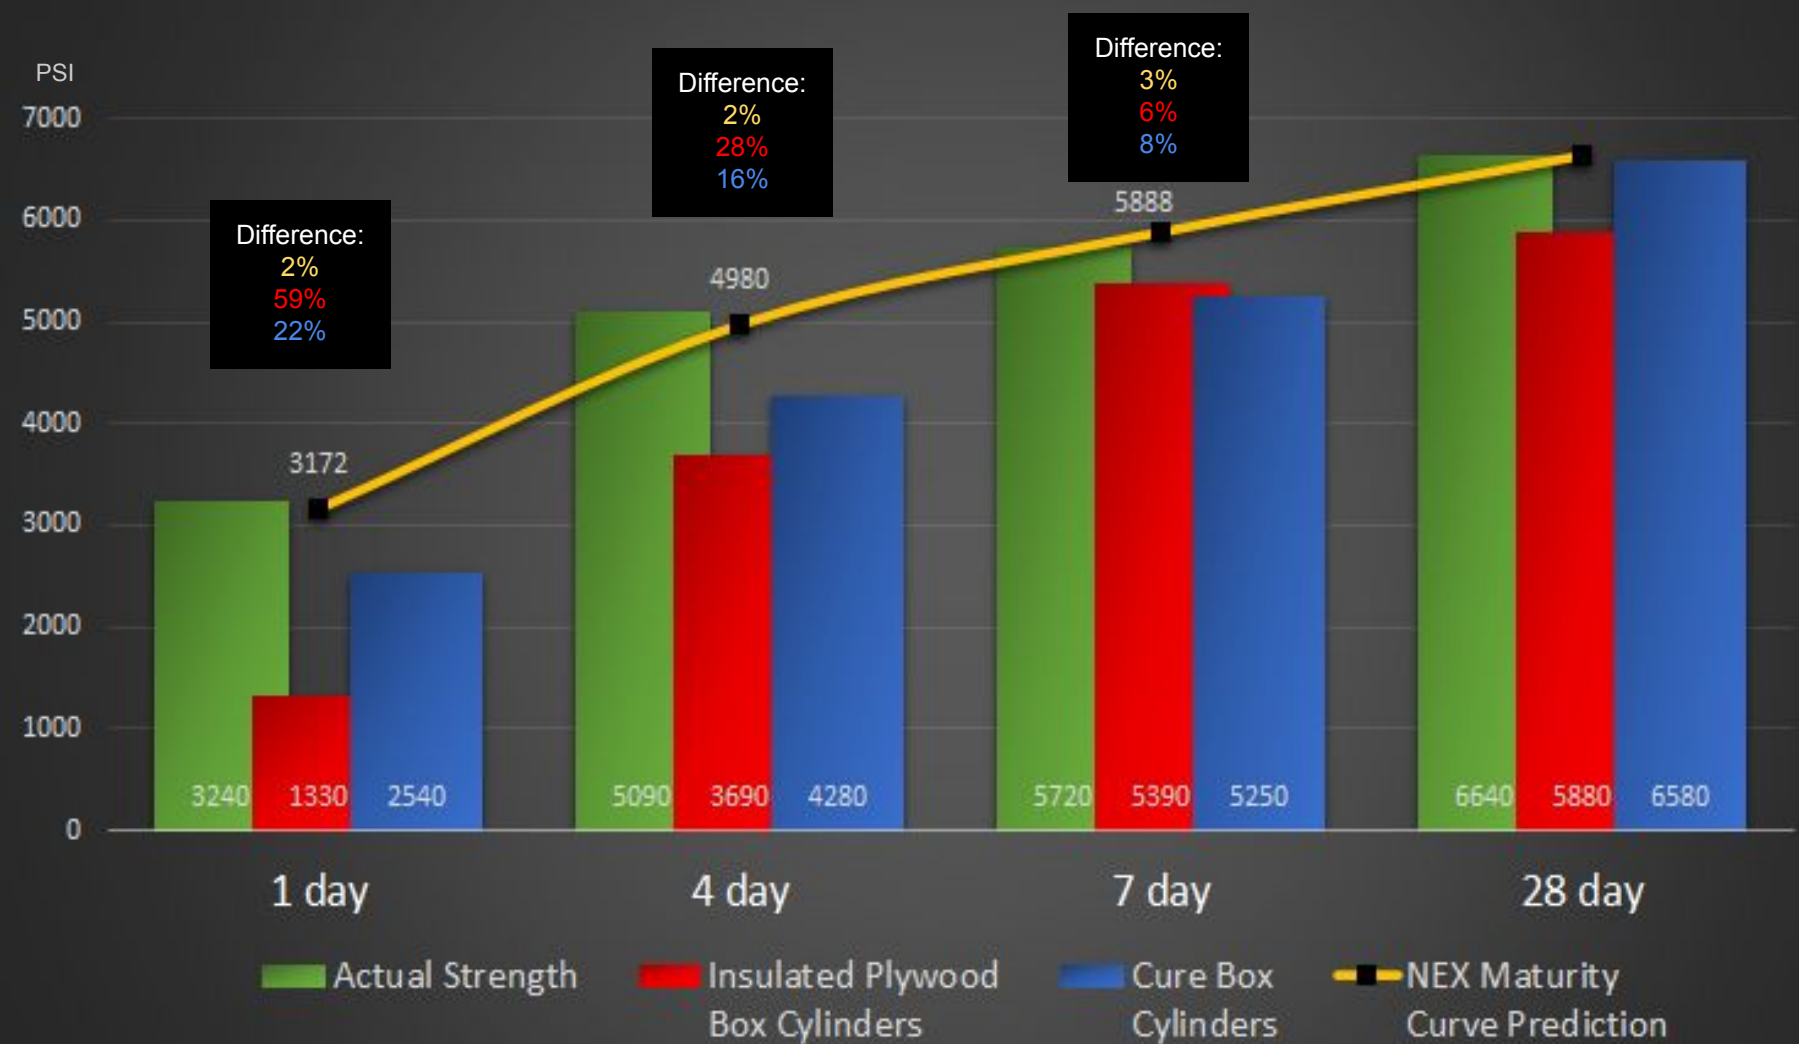
# 24 Hour Cylinder Break Results

2% difference

3172

*NEX®* Maturity  
Prediction

59% difference

1330

Insulated  
Plywood Box

22% difference

2540

Constant Temp  
CureBox

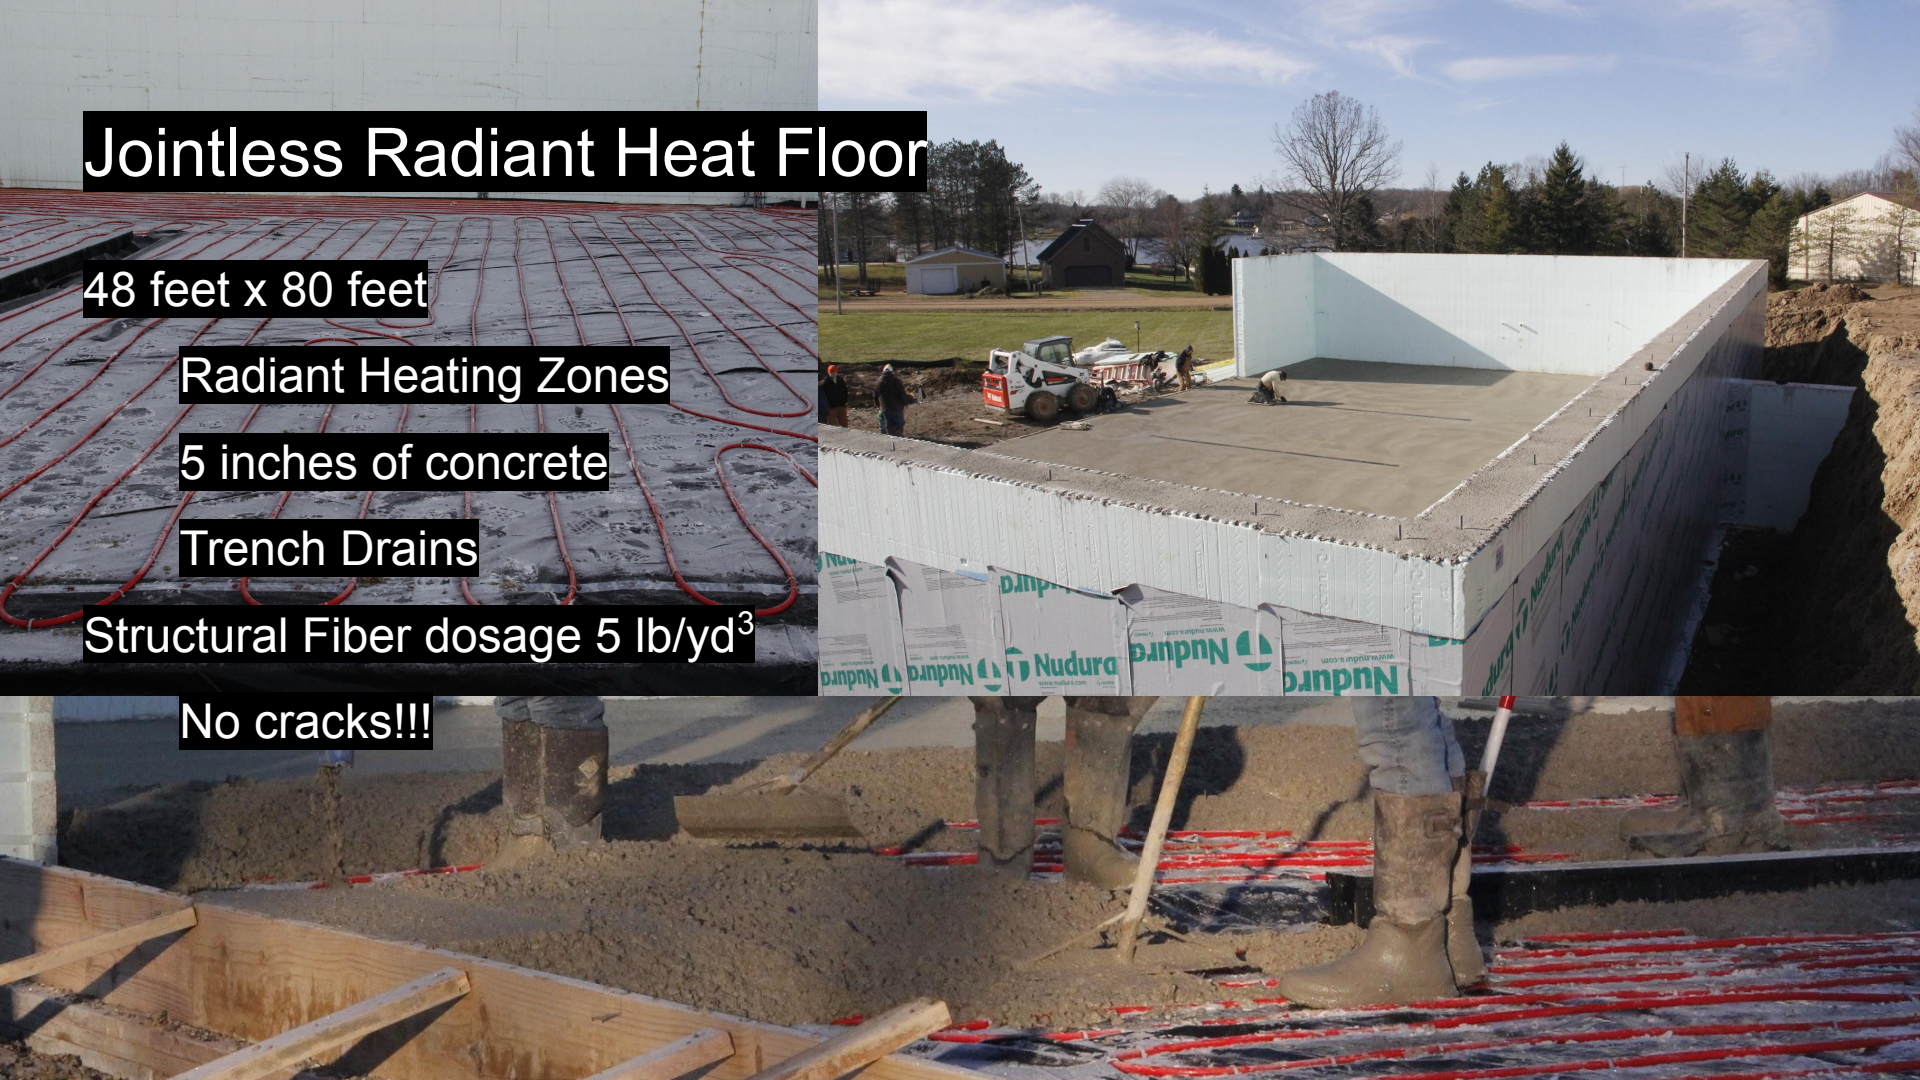
# Jointless Radiant Heat Floor

48 feet x 80 feet

Radiant Heating Zones

5 inches of concrete

Trench Drains

Structural Fiber dosage 5 lb/yd<sup>3</sup>

No cracks!!!

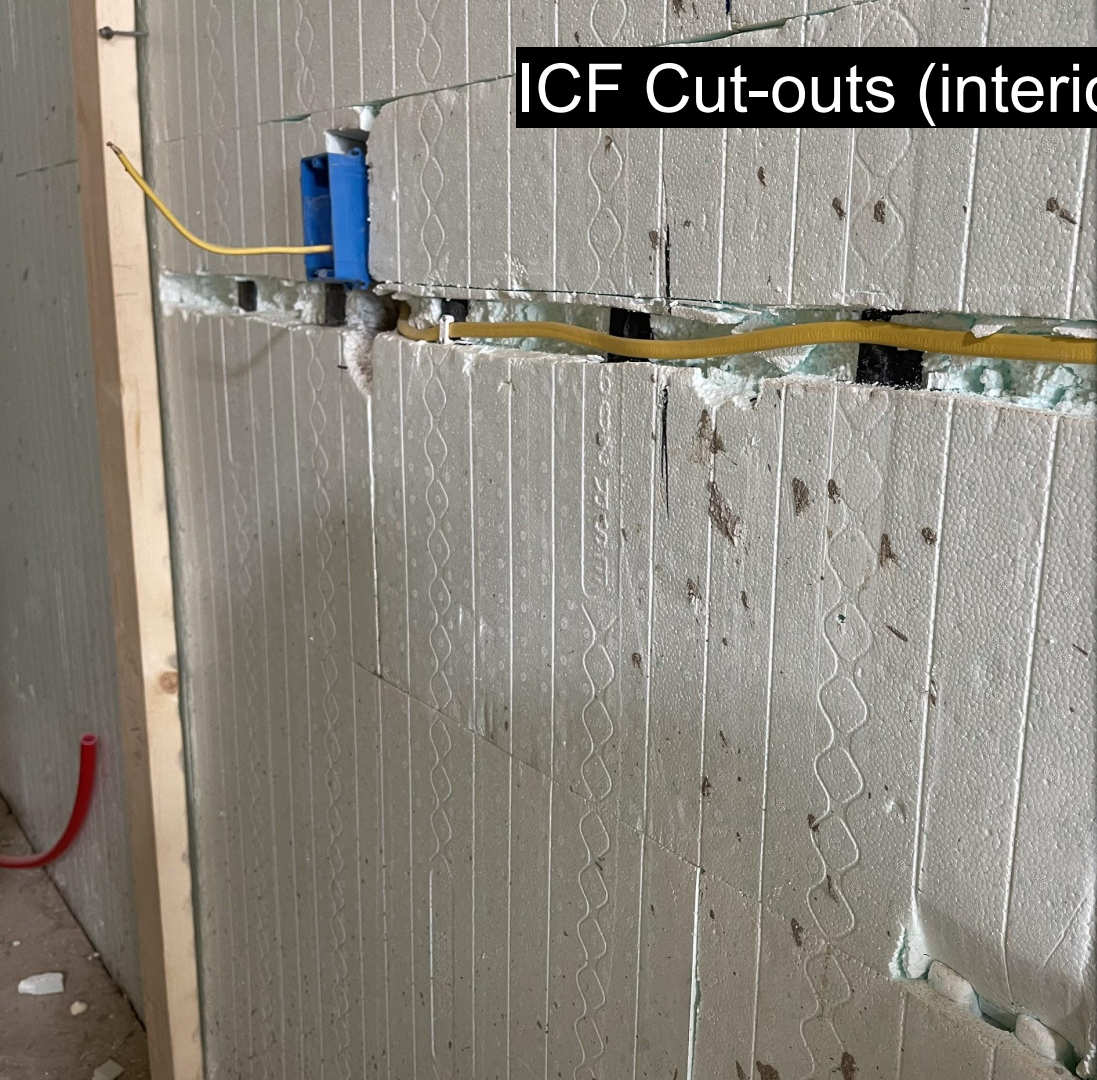
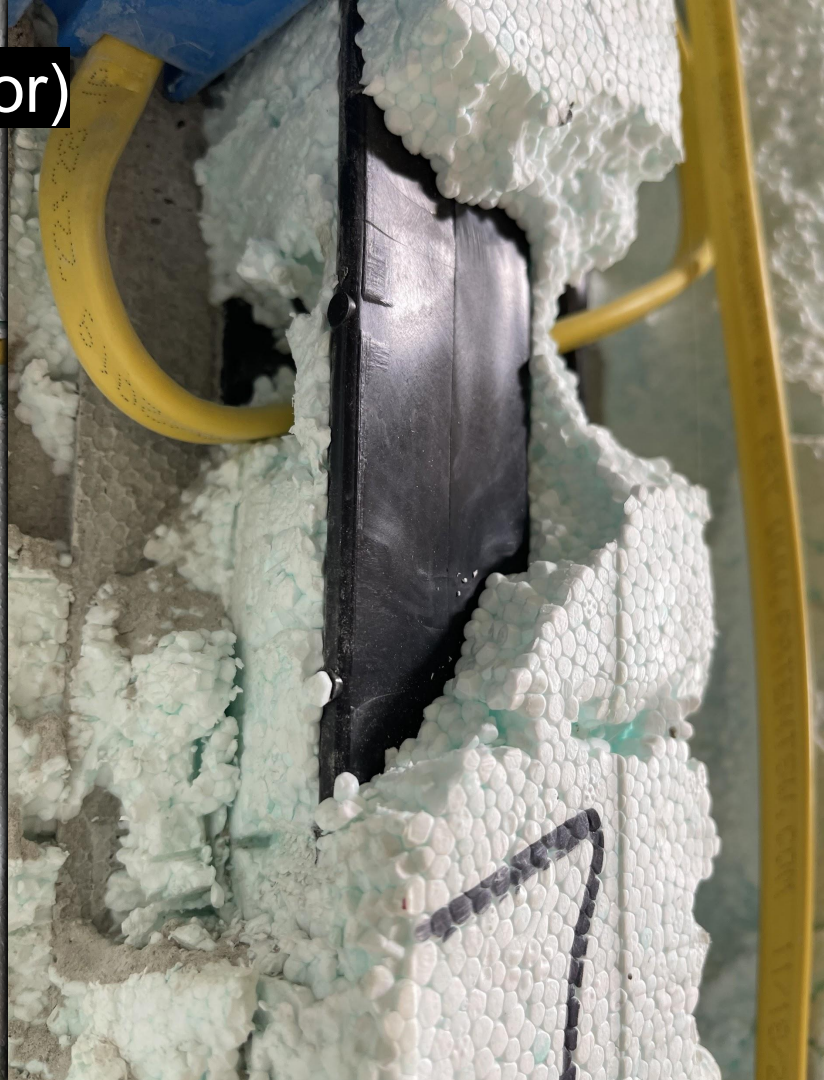
# ICF Cut-outs (interior)

4" closed-cell insulation  
and knee wall
